# Manhole Inspection Summary

Manhole # S15AA2016MH

Insp Date: **10/2/06 11:04 AM**

**Location** Address: **5604 WEXFORD RD**

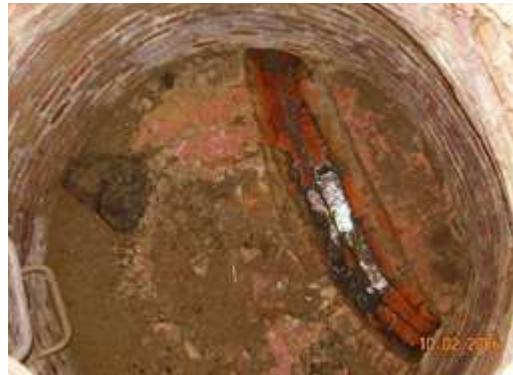
Top View

Infiltration: ☐ None ☐ Joint ☐ Cracks ☒ **Mortar** ☐ Roots ☐ Wall

**Bench** ☒ Exists Material: **Brick** ☐ Parged ☒ **Debris** (not Condition related)

**Surcharge** ☒ **Evidence Of Surcharge** Depth: **1** (ft.) ☐ Active Surcharge Present

Barrel infiltration. Evidence of surcharge - Bench debris.

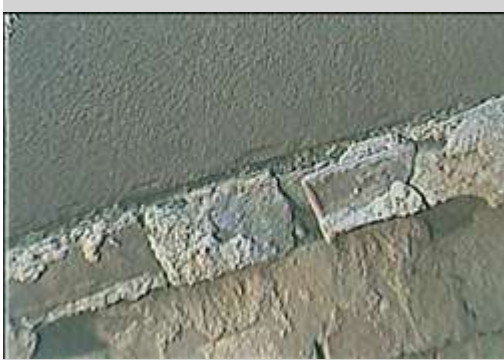
Defect

**Frame** Offset: **2** (in.) Condition: ☐ Sound ☐ Cracked ☒ **Leaks**

Condition: ☐ Sound ☒ **Cracked** ☐ Root Intrusion ☐ Loose Brick ☒ **Deteriorated**

Infiltration: ☐ None ☒ **Joint** ☒ **Cracks** ☒ **Mortar** ☐ Roots ☐ Wall

Frame leaks. Adjustment cracks, deterioration, and infiltration.

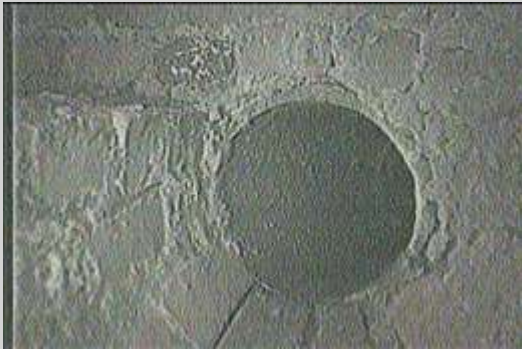
### 8 in. Circular Gravity Sewer Pipe Out @ 12 O'Clock

Infiltration: **Evidence** Pipe Seal Cond: **Unknown**

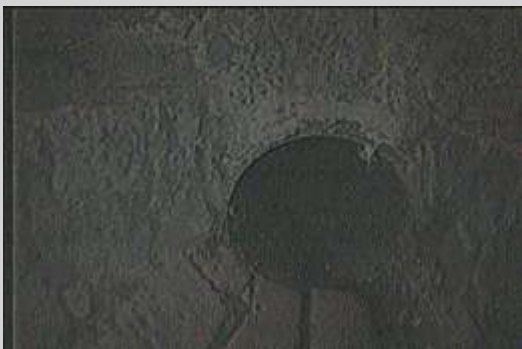
### 8 in. Circular Gravity Sewer Pipe In @ 4 O'Clock

Infiltration: **Evidence** Pipe Seal Cond: **Unknown**
